operation and maintenance

Carter Lake gate rehab project

By Mark Dowling

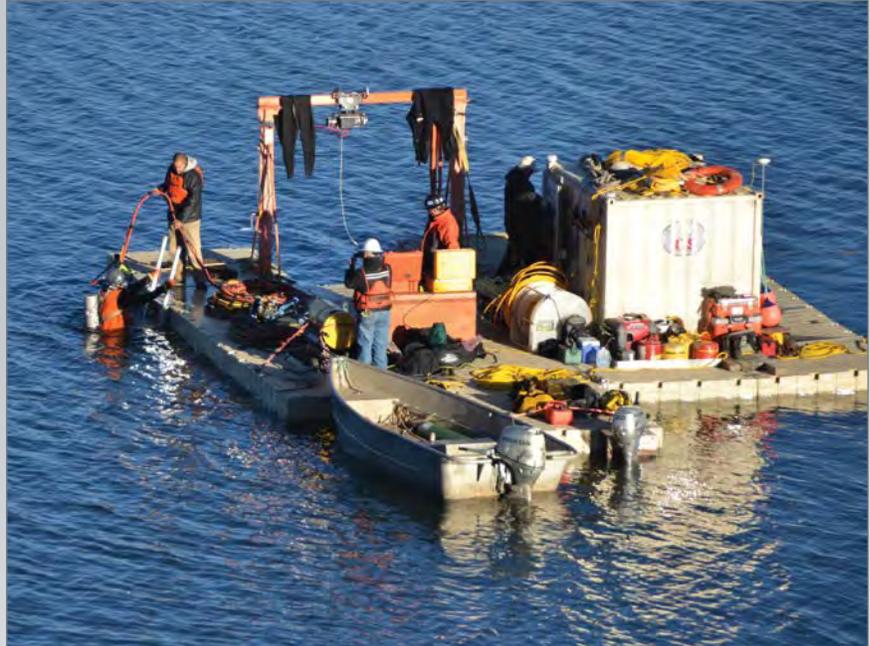
An Associated Underwater Services (AUS) dive crew begins the inspection process to evaluate the condition of the gates.

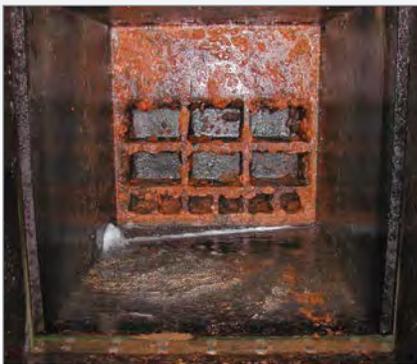
The gates had significant corrosion. They were sandblasted, welded and repainted. However, the brass seals on the gates and gate thimbles (steel framework housing the gates) were in perfect condition, and did not require replacement.

Corrosion on the left guard gate

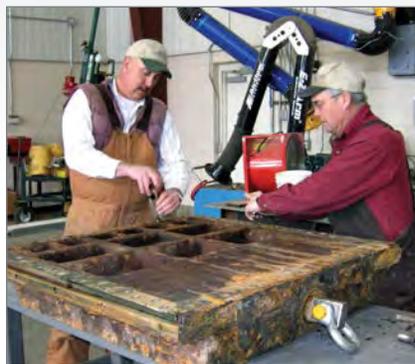
Workers repair gate

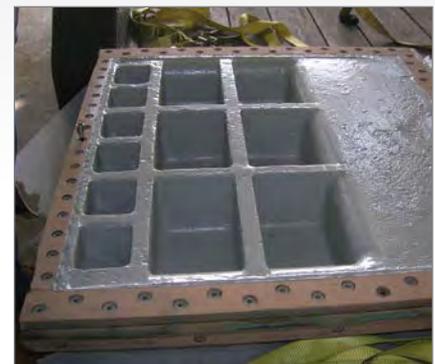
Refurbished operating gate

Completed in March 2008, the new \$12 million Carter Lake outlet provides operational flexibility and built-in redundancy, and it enabled work to begin on the original outlet. During spring 2011 crews removed, rehabilitated and reinstalled the twin operating gates.

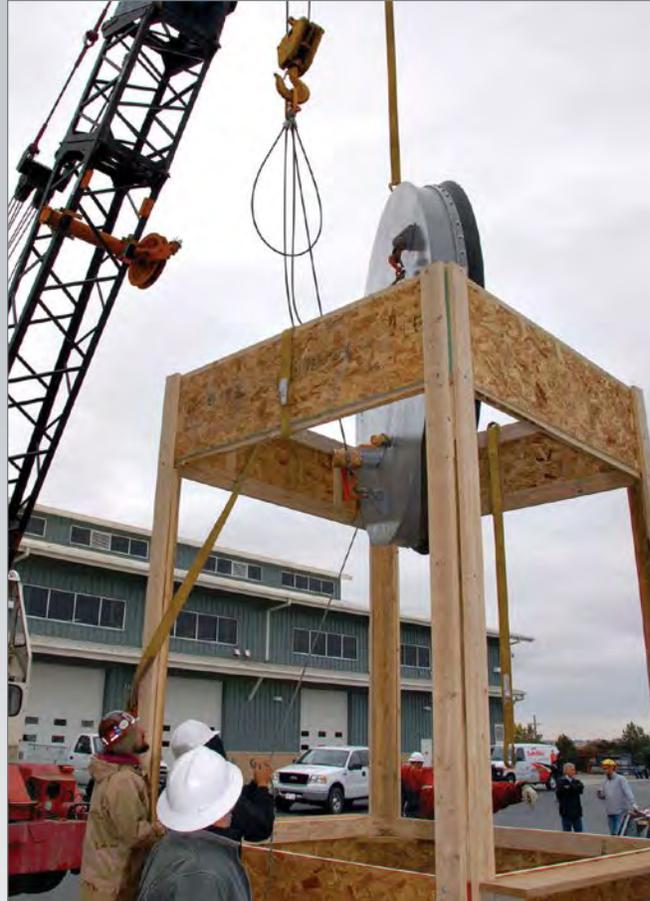
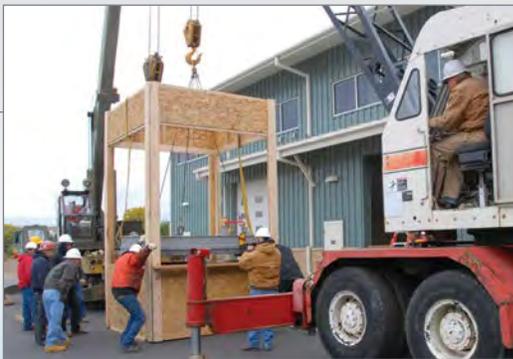
Temporary Bulkhead
(placed for maintenance)

Inlet Structure

Guard Gates
(Always open unless maintenance is performed on the operating gates)

Valve House

Dam #1

Operating Gates
(Regulates flow)

To temporarily drain – or “de-water” – the tunnel leading from Carter Lake to the gates (enabling the gates to be removed), a bulkhead or plug was created for the intake to keep water out of the tunnel.

Crews then de-watered the outlet works and hoisted the upstream guard gates to the top of the dam via a 170-foot vertical shaft. Northern Water refurbished the gates, put them back in place, removed the bulkhead and refilled the tunnel with water.
