# **CYANOBACTERIA MONITORING RESPONSE AND COMMUNICATION PLAN**

**Grand Lake, Shadow Mountain Reservoir, Lake Granby and  
Willow Creek Reservoir**

Prepared by: Grand County, Northern Water, Three Lakes Watershed Association, Town of Grand Lake, US Forest Service, US Bureau of Reclamation

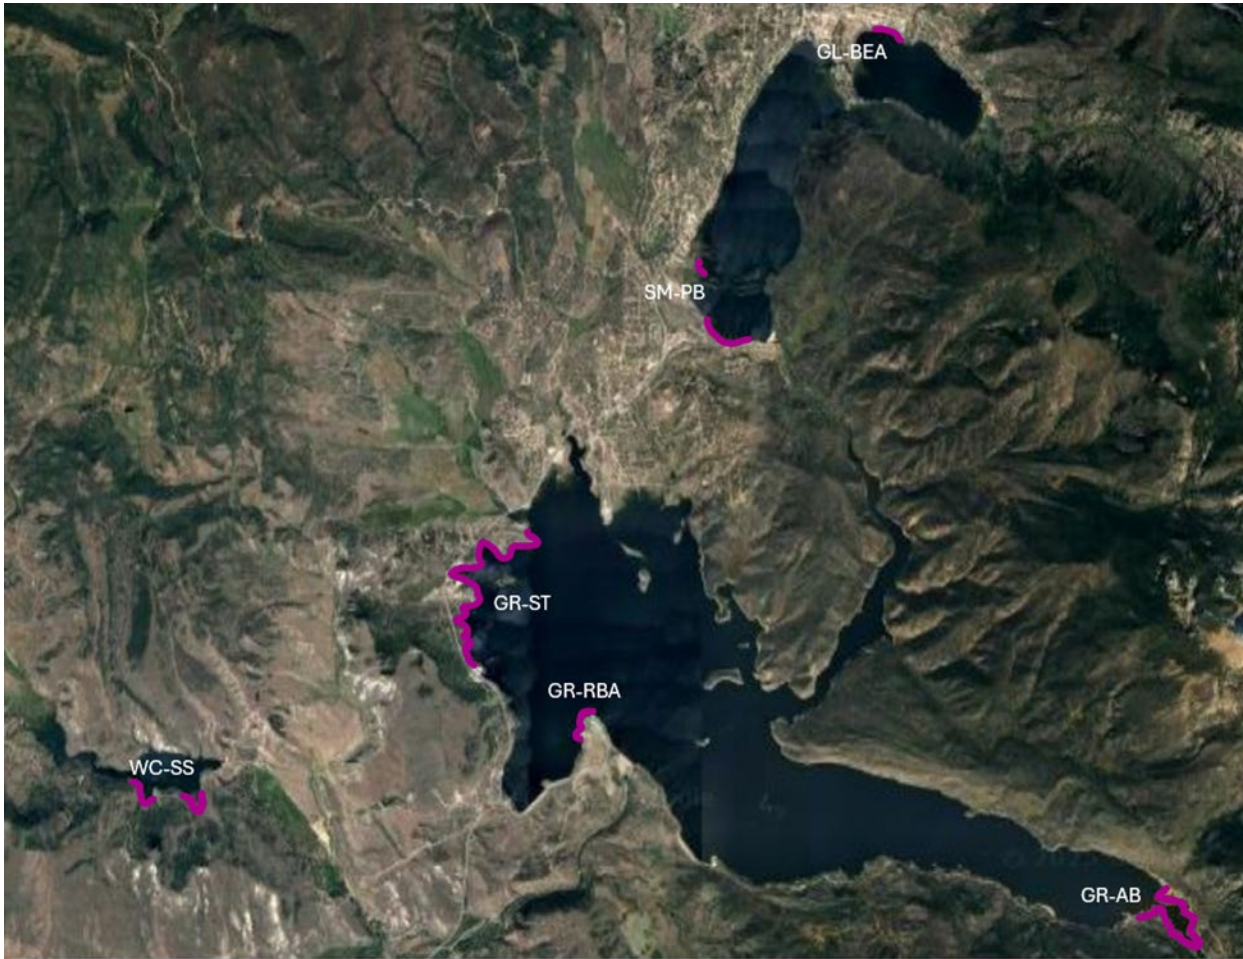
Figure 2. Map of weekly site visit zones.

There are six monitoring “zones” where recreational water contact is common and regular site visits will occur: one each in Grand Lake, Willow Creek Reservoir and Shadow Mountain Reservoir, and three in Lake Granby (Table 3). The zones are located along the shoreline in high-use, public access areas where there is contact recreation (Figure 2). The coordinates for the sites represent the general area that will be monitored; samples can be collected at any location along the shoreline within the routine monitoring zone where cyanobacteria are visible. If cyanobacteria are visibly present in multiple regions within a monitoring zone, the area that contains the highest apparent concentration will be sampled. Grand County Water Information Network (GCWIN) will perform the weekly site visits following the Monitoring Flowchart (Figure 3). Site visits will occur from mid-June through mid-October, depending on if conditions are conducive to cyanotoxin production. All sites other than GR-AB are monitored weekly, while GR-AB is monitored every other week because of the distance away from other monitoring locations.

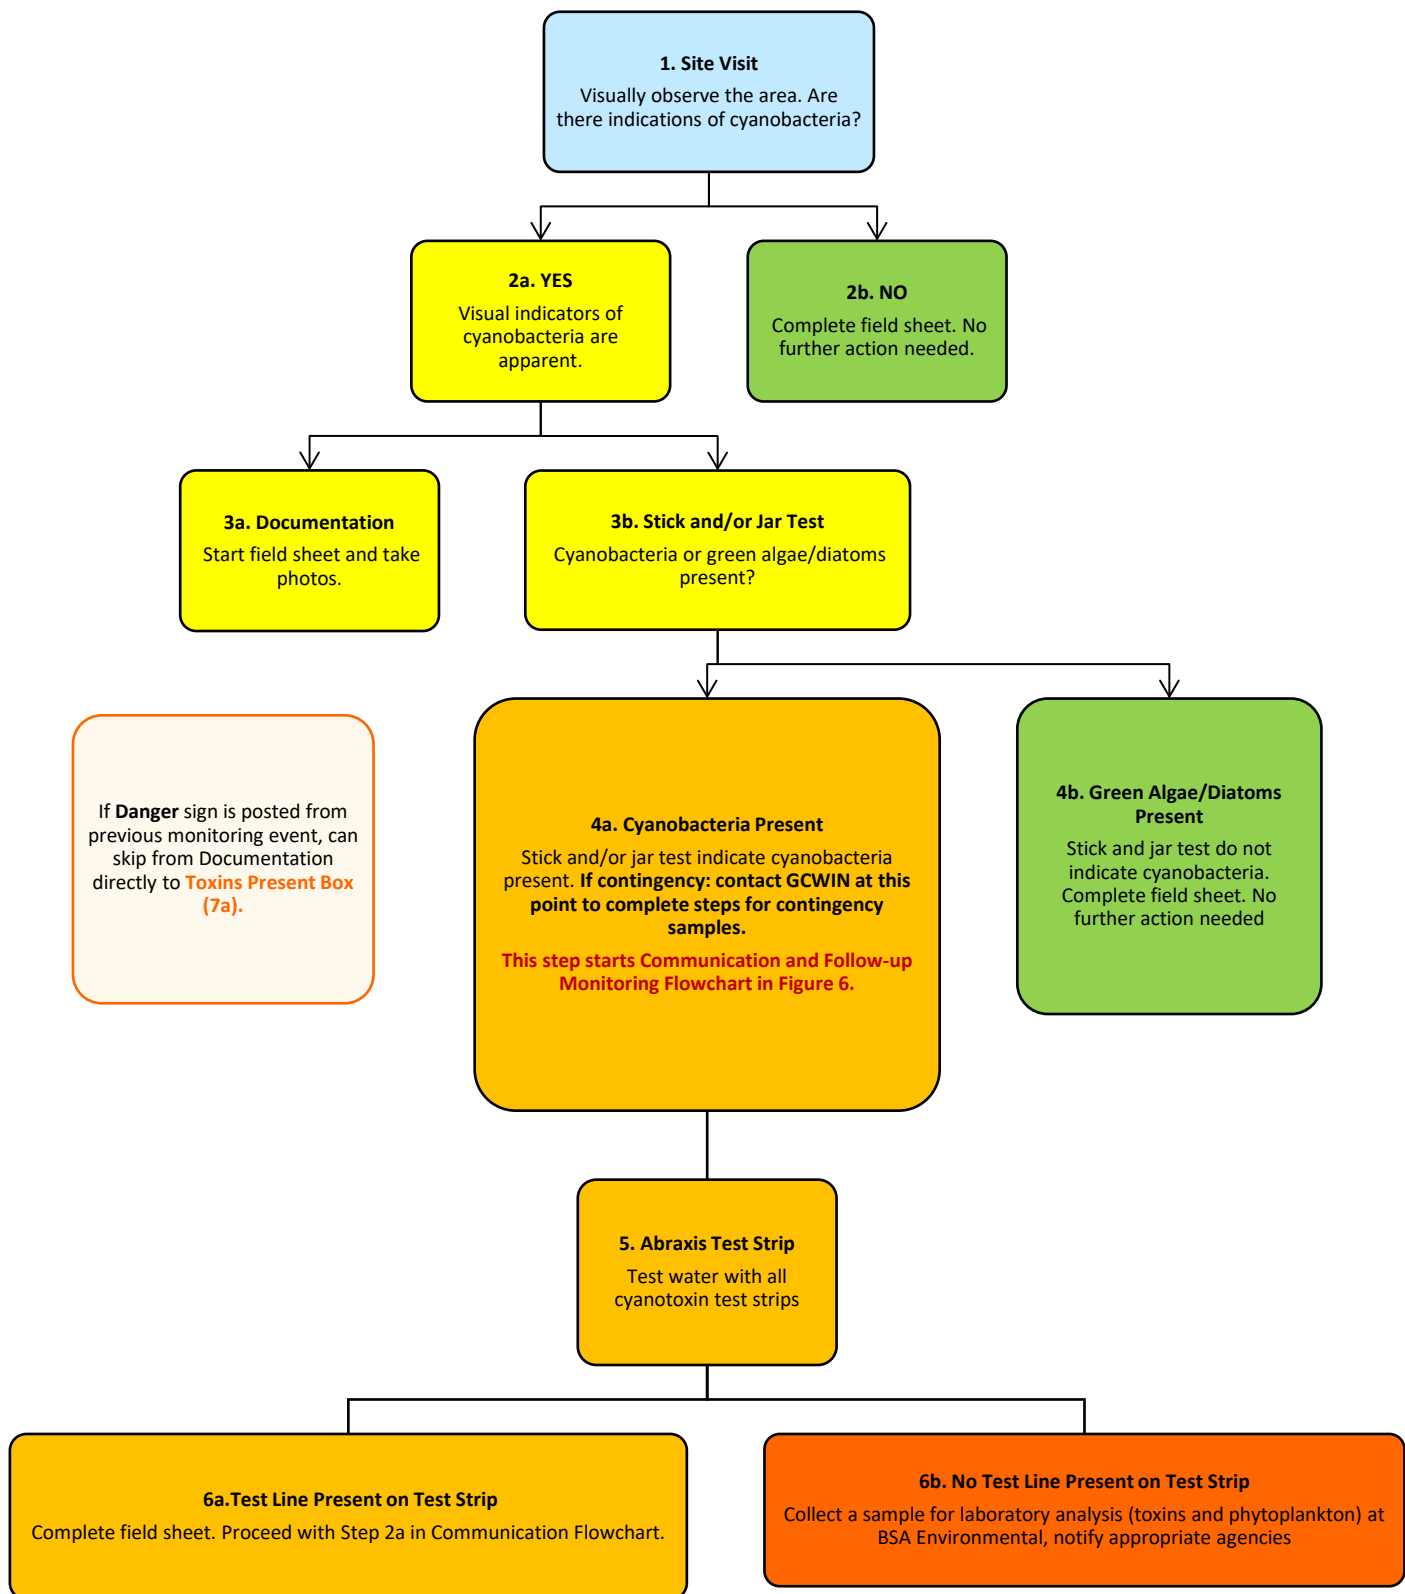
Figure 3. Monitoring Flowchart

The monitoring steps required during either a weekly site visit or contingency site visit follow guidance from [CDPHE \(2020\)](#). The Monitoring Flowchart (Figure 3) outlines the steps that will be taken to determine the presence/absence of cyanobacteria and cyanotoxin. Either GCWIN or a partner agency can conduct the field observations to investigate and verify any reports of visual presence of cyanobacteria following the steps shown in the monitoring flowchart, up to the "stick" and/or "jar test" step (Monitoring Flowchart, Steps 1-4). If the stick and/or jar test indicate the presence of cyanobacteria, GCWIN will complete the remaining steps (Steps 5-7). The cyanotoxin test strips will be used to determine if a sample should be sent to the lab for further quantification. If there is no test line present for a cyanotoxin test strip, a sample should be sent to BSA Labs for quantification. Concentrations where the test line is present are below toxin advisory levels for recreation from CDPHE for each cyanotoxin and therefore a sample does not need to be sent to BSA Labs for quantification. Each part of the flow chart is described below.

If the results from the laboratory confirm cyanotoxins are present, follow the Communication and Follow-up Monitoring Flowchart (Figure 3). First, the partners will be contacted to coordinate a response. Partners will issue public notifications immediately (i.e., warnings, advisories, or closures) based on the cyanotoxin level and the risk it presents to human and animal health. To promote quick placement of signage, Northern Water will notify the contacts from the Town of Grand Lake if cyanobacteria are identified in Grand Lake and will notify the USFS if cyanobacteria are identified in *any* of the water bodies. Each entity will be responsible for contacting additional people within their organization. Partners will monitor and sample the waterbody to confirm or modify the notification until lab tests show the cyanotoxins are below safe levels and visual signs of the bloom are gone.

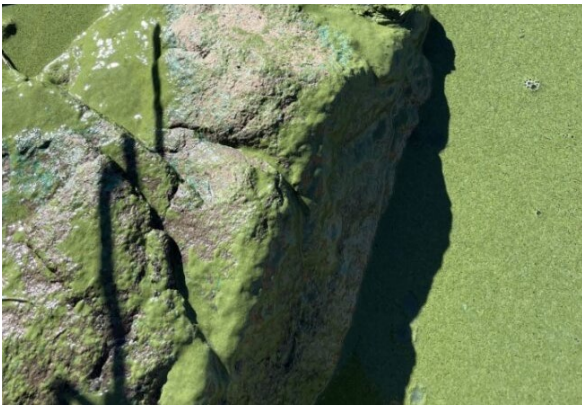
Site visits begin with a visual inspection of the water to assess whether cyanobacteria may be present. Visual signs of cyanobacteria in the water include:

- Surface water discoloration, which can be green, white, red, or turquoise.
- Cyanobacteria blooms can resemble thick pea soup or paint; there is reduced water transparency.
- Thick mats of algae and scum can form along the shoreline.
- Small specks of algae floating on or just below the surface.
- Cyanobacteria blooms are **NOT**: stringy, filamentous or mustard yellow in color.

Figure 4. Image of potential cyanobacteria.

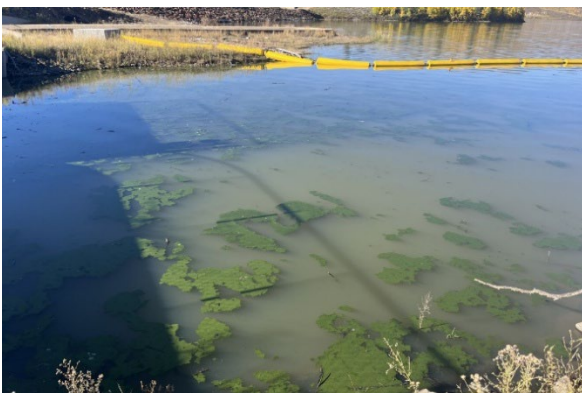
Figure 5. Image of potential cyanobacteria.

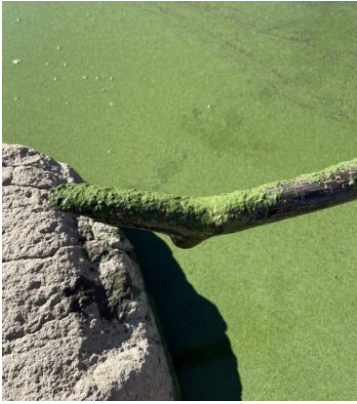
A stick test is a simple field test that requires a sturdy stick to be dipped into the algae bloom. After it is dipped, the residue on the stick is observed. If the stick has long, string like, filamentous algae attached to it, it is likely green algae. Green algae are not harmful as they do not produce cyanotoxins. If the stick has a thick coating of non-filamentous algae or looks like it has been painted, it is likely cyanobacteria and additional testing is needed (move to Monitoring Flowchart Step 5 “Abraxis Test Strip”).

Figure 6. Example stick test showing likely presence of cyanobacteria.

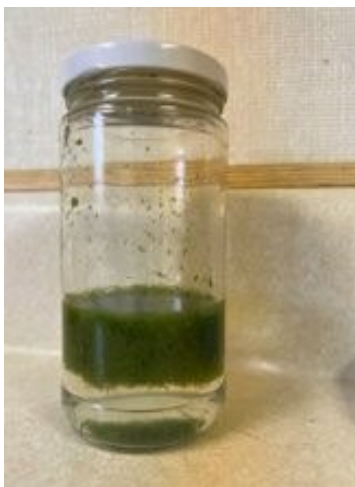
Cyanobacteria have the unique ability to control their buoyancy in water. The jar test is a qualitative bench test that allows for visual determination of whether cyanobacteria are present in a water sample. After a resting period, cyanobacteria in a jar placed indoors will accumulate on the surface, where green algae will remain distributed throughout the water sample. The following method is used for the jar test, which is modified after City of Boulder Algae and Cyanotoxin Response Annex, May 2021 (References and Resources).

3. Wipe off the outside of the jar and place a lid on the jar.
4. Keep the jar out of the wind (do not shake or agitate the jar in any way).
5. If cyanobacteria are present, they will tend to accumulate as a layer in the upper portion of the sample (note this could take 30 minutes or up to 8 hours or longer if blooms are small). Green algae (which are harmless) will not demonstrate this accumulation and will remain distributed throughout the water column or settle near the bottom. Figure 7 shows an example of cyanobacteria accumulation at the top of the jar (right).

Figure 7. Image of a jar that indicates likely presence of cyanobacteria.

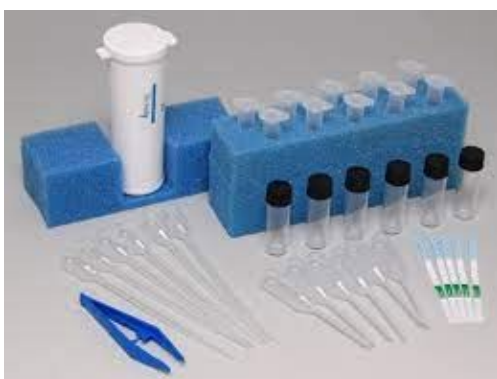
Abraxis Test Strips are used to determine the presence or absence of cyanotoxins (Figure 8). The test strips used for this program are for drinking water source supplies and have a lower detection limit than the ones commonly used for recreation. This provides more certainty in the results if cyanotoxins are detected. The detection limits for each strip are shown in Table 4. The test strips will be used following the user's guide and instructions provided with the test strip kit.

Figure 8. Abraxis Test Strip Kit

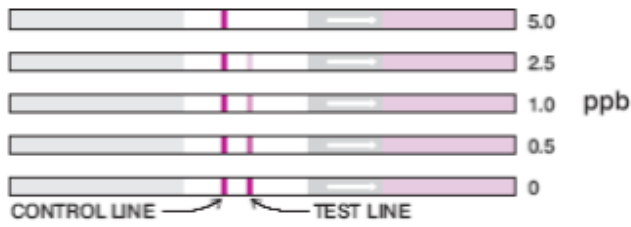
sample will be collected and sent to BSA Labs for quantification (Figure 9). If no test line is present on the test strips, the test indicates that the cyanotoxin concentrations are at or above the values displayed in Table 4. If the test line is present on the test strips, the test indicates that the cyanotoxin concentrations are below the values displayed in Table 4. Each of these values displayed in Table 4 are below the CDPHE Toxin Advisory Levels for Recreation displayed in Table 1. For example, language from the Microcystin test strip instructions reads: "Test strips with a test line which is lighter than the control line indicates a result which is < 5 ppb. Test strips with no test line visible (only the control line is visible) indicates a result which is  $\geq 5$  ppb." The same interpretation is consistent with the methods of interpretation for the other cyanotoxin test strips only with the values being different for each. The test strips provide qualitative results, the laboratory analysis will provide quantification of toxin concentrations.

Figure 9. Example test strip instructions from a microcystin Abraxis Test Strip. If no test line is present, sample concentrations indicate potential concentrations of cyanotoxin above the detection limit, indicating that a sample should be sent to the lab.
